**Supplemental Agreement 2
Environmental Investigation
Final Report
Terminal 106 West
Seattle, Washington**

January 1992

**RE: SUPPLEMENTAL AGREEMENT 2, ENVIRONMENTAL INVESTIGATION
 FINAL REPORT; TERMINAL 106, SEATTLE, WASHINGTON**

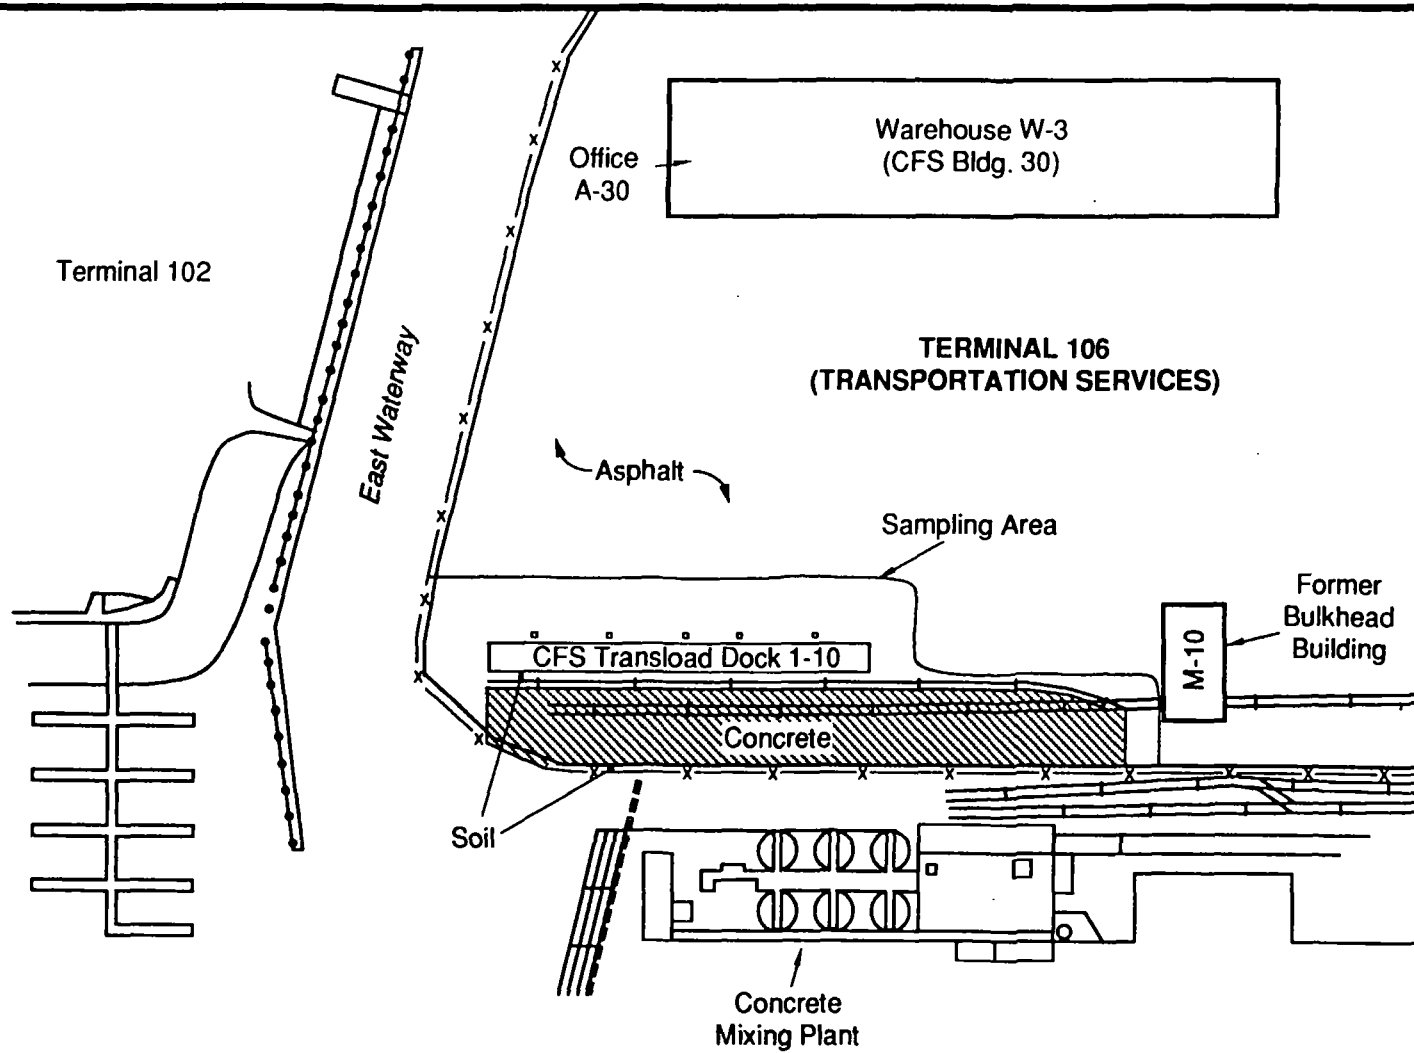
FIG. 1

The transload dock is a concrete platform with a timber and metal post roof structure. The platform measures approximately 20 feet by 275 feet. A 25-foot ramp is located on the east side of the dock. North of the transload dock is an asphalt-paved area. Warehouse W-3 (CFS Building 30) is located north of the paved area. Two active east-west trending railroad spur tracks are located 5 and 20 feet south of the transload dock. The area between the dock and the northernmost track is not paved. A concrete slab is located 20 feet south of the transload dock. The site is bordered to the south by Stoneway Concrete and to the west by the East Waterway of the Duwamish Waterway. East of the site are various warehouse buildings and Duwamish Avenue South. A chain link fence secures the site. A gate is located at the east end of the site and access is controlled by a Port security guard. The site plan and adjacent properties are shown in Figure 1.
